Comprehensive Kiln Alignment

Lou Lovas, North American Kiln, USA, describes how kiln stability can be maximised by aligning all interacting mechanical components.

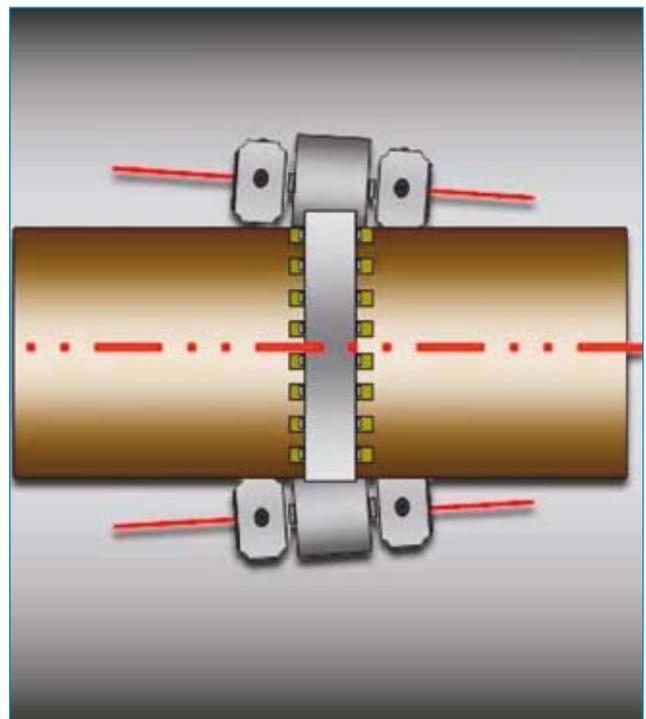
Figure 1. Rollers misaligned relative to the kiln axis are mechanically unstable. Stability requires that rollers be parallel to the kiln axis to within 0.008 in./ft. or less.

The alignment of support rollers relative to the kiln axis is a very important alignment requirement that is rarely addressed in relevant procedures. If a roller is not parallel to the kiln axis, the direction of rotation of the roller is slightly different from the direction of rotation of the kiln. The undesirable consequences are as follows.

In addition to the rotation of the roller along a line perpendicular to the kiln axis, there is an axial roller motion component, resulting in a) high bearing end cap pressures, or b) high roller shaft thrust collar pressures, depending on the bearing design. High thrust mechanism pressure in bearings generates heat and thus increases the bearing temperature. Most hot bearings are hot because of this pressure condition.

A very important note regarding support roller thrust loads: stable thrust roller load is not an indication that support roller bearing adjustments are not required. It is typically the case that some rollers that are misaligned push the kiln uphill, and some downhill. The net effect may be perfectly acceptable thrust roller load, with very inadequate overall kiln stability. Figure 1 shows a pier where one roller is pushing hard uphill and the other pushing downhill. The net effect on thrust roller load is zero, but both rollers are unstable. It is therefore important to measure and adjust the thrust load on every support roller as part of a kiln alignment.

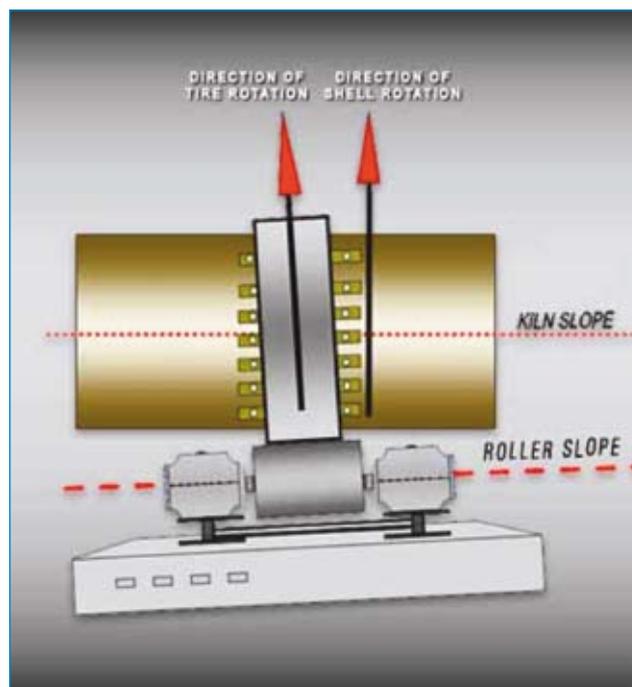
Figure 2. Tyres must be aligned perpendicular to the shell axis to assure low tyre retainer pressures. This can only be done by adjusting the roller slopes.

As depicted in Figure 2, if the plane of a tyre is not perpendicular to the kiln axis, the direction of rotation of the tyre is not the same as the direction of rotation of the shell. Given that condition, the tyre creep has a horizontal motion component, which is the cause of high tyre retainer pressure. This pressure is always caused by the misalignment of the tyre plane relative to the kiln axis. Contrary to conventional wisdom, it is never caused by improperly adjusted support roller bearings; consequently, high tyre retainer pressure cannot be corrected with bearing adjustments. Correcting the problem requires changing the support roller slopes and thereby tilting the tyre plane relative to the kiln axis. The magnitude of the necessary roller slope changes should be ascertained as part of a kiln alignment. Corrective measures can then be implemented during a shutdown.

An interesting digression: it is possible to have two rollers push a tyre uphill, and have the tyre exert high pressure on the downhill tyre retainers, and vice versa. This occurs if the horizontal motion component of the tyre creep is in the direction opposed to the support roller thrust load direction.

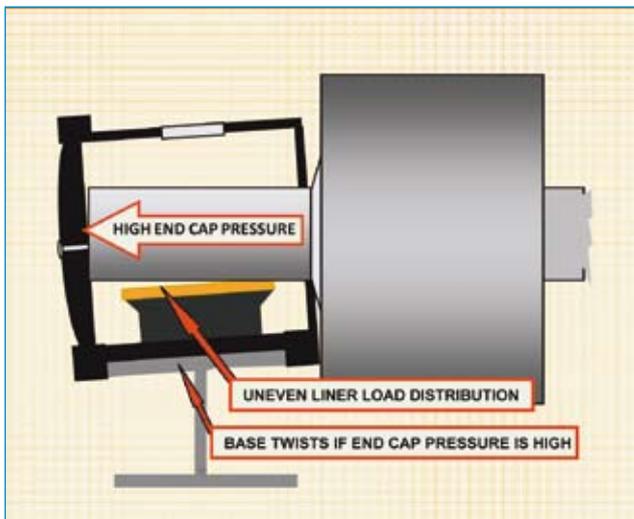
Figure 3. Misalignment of bearing relative to roller shaft. The root cause is high end cap pressure caused by roller axis misalignment relative to the kiln axis.

An important alignment consideration is the alignment of support roller bearings relative to the roller shafts they support. As illustrated in Figure 3, a base plate often twists as a result of high bearing end cap pressure. If such base distortion occurs, the bearing liner will be misaligned relative to the roller axis. The condition causes uneven liner load distribution. The liner area sustaining the maximum load can generate too much heat for the cooling system to dissipate. Unstable bearing temperatures often result. The problem can be detected by measuring the slope of the bearing housing and comparing this slope to the roller axis slope. If the two slopes differ by more than 0.003 in./ft., the housing has to be tilted using shims. The need for such alignment correction should be identified as part of a kiln alignment.
